# PROPERTY INSPECTION REPORT

Apex Home Inspections, LLC

Inspection Prepared For: Random Client

Date of Inspection: 6/20/2019

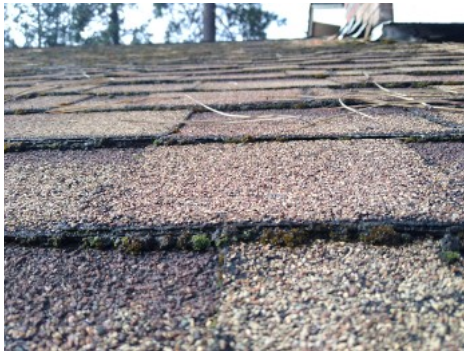
- Light moss on roof. Be sure to check for and treat moss as a part of annual maintenance.
- Some exposed fiberglass and missing granules.

light moss

zinc strip on the ridge will help prevent some moss growth but will not guarantee no moss growth

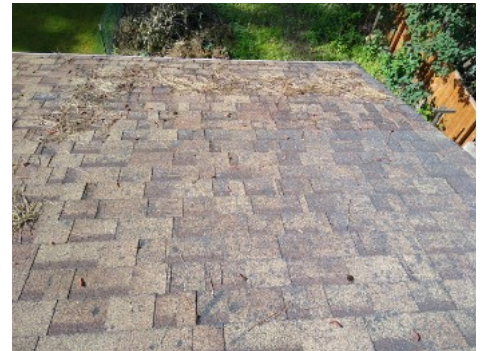
slight granule loss on this portion of the roof

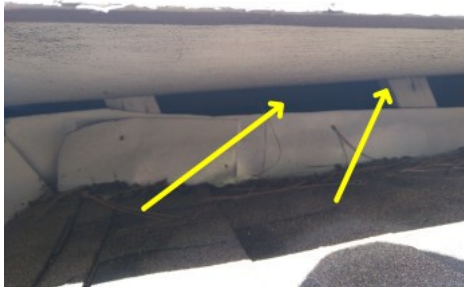
- Sidewall flashing was improperly installed. It is not backed by siding. This area is opened up to the Attic.

opened up to attic

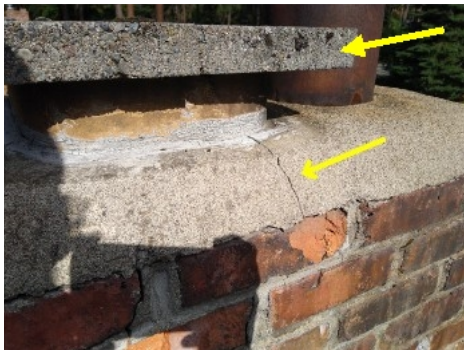
- The chimney crown was constructed using concrete. Concrete is very durable and concrete caps typically have a long service life.
- Minor cracking was visible in the chimney crown.
- Counter-flashing designed to work in conjunction with flashing where the chimney penetrated the roof was poorly installed. This condition may allow moisture intrusion.
- Chimney shows signs of minor deterioration on the brick, the mortar, and the crown. Deterioration appears commensurate with its age.
- **The terracotta chimney flue was blocked with pavers. Be sure to remove these when using the fireplace/stove that this flue is connected to.**

minor cracking and blocked flue

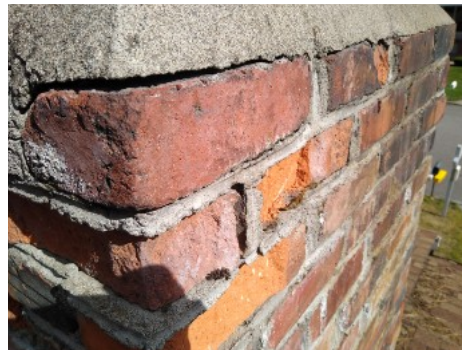
deterioration of brick and mortar

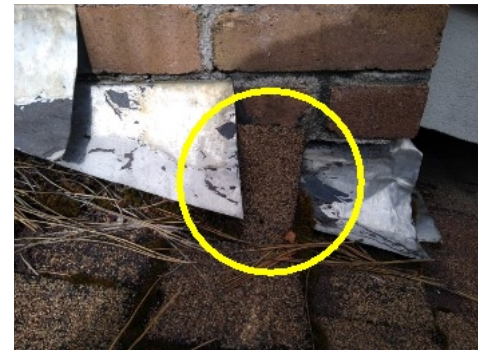
incorrect installation

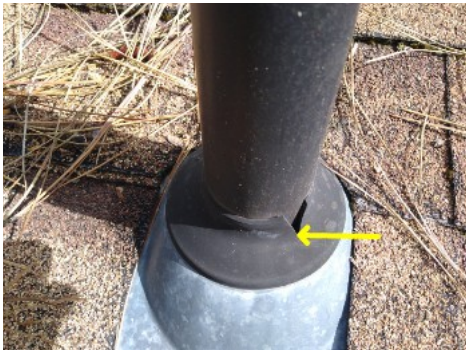
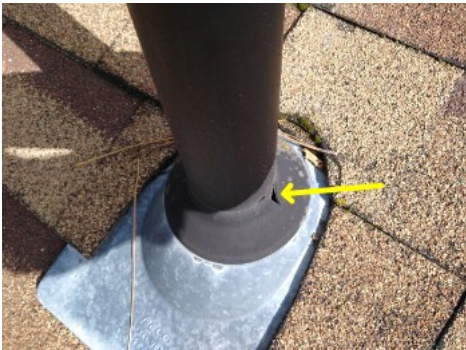
- The rubber boot at a roof plumbing vent pipe was damaged and may allow moisture intrusion of the roof assembly.

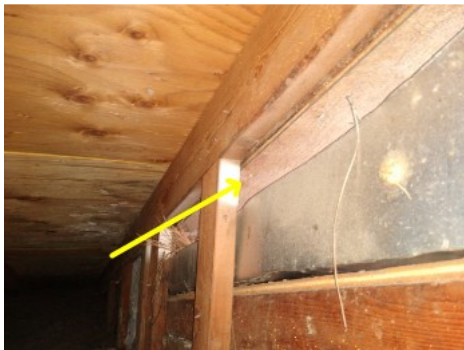
Page 8 Item: 2	Structure	<ul style="list-style-type: none"> <li>• Siding is missing where the garage attic meets the house attic.</li> <li>• Roof sheathing shows signs of previous moisture intrusion.</li> </ul>
Grounds

- Siding is missing where the garage attic meets the house attic.
- Roof sheathing shows signs of previous moisture intrusion.

missing siding and sheathing

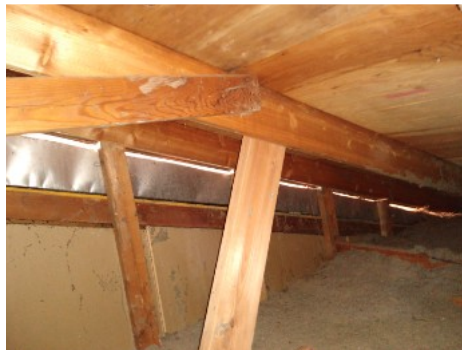
missing siding and sheathing

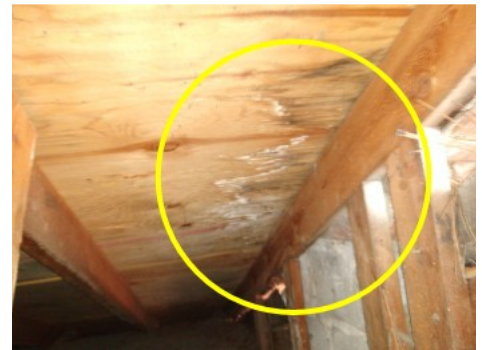
previous moisture intrusion

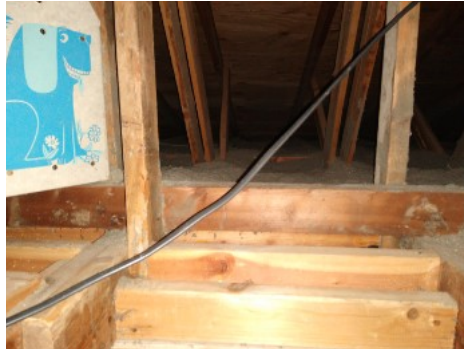
- All wiring should be properly secured to the framing.

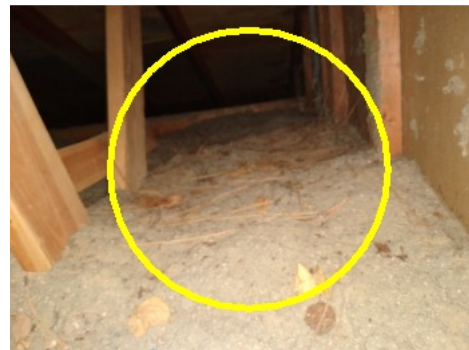
pine needles and debris

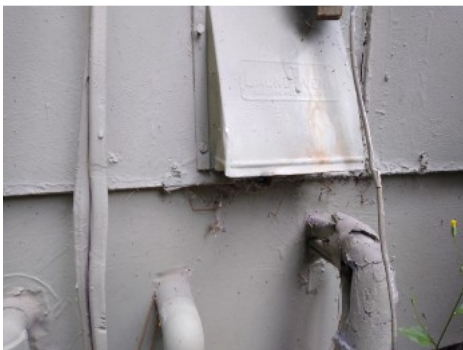
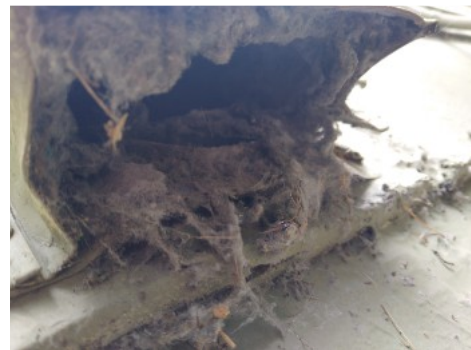
- A decent amount of lint buildup is present at the exterior dryer vent. Be sure to remove dryer vent lint on a regular basis.

lint build up

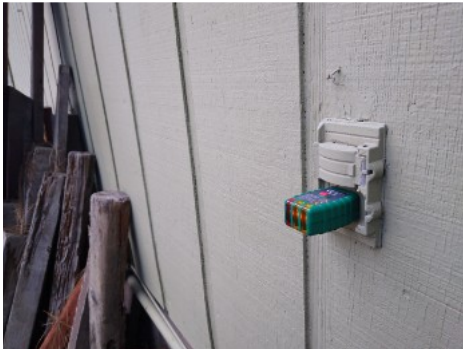
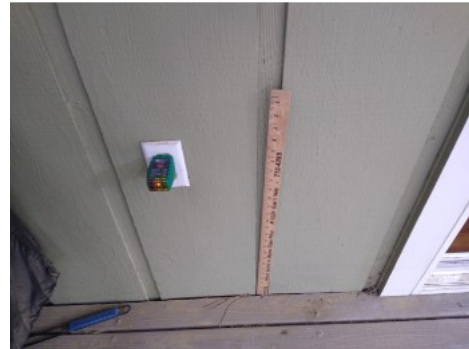
- Weatherproof outlets—Exterior outlet and switch cover(s) not waterproof. Have certified electrician evaluate and repair as necessary.
- No exterior outlets appear to be **GFCI** protected. Although this may have been common during the construction of this house, modern standards have all exterior outlets as GFCI protected.
- Exterior outlet shows open ground condition and is not GFCI protected.

open ground condition

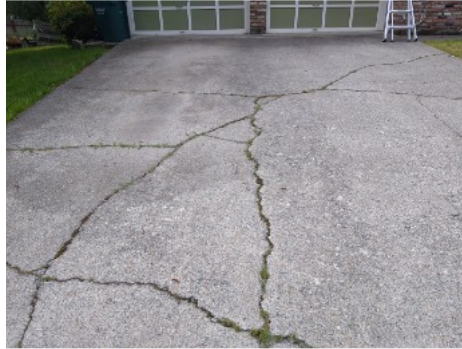
- Common cracks (1/4-inch or less) were visible in the driveway. Cracks exceeding 1/4-inch should be filled with an appropriate material to avoid continued damage to the driveway surface from freezing moisture.

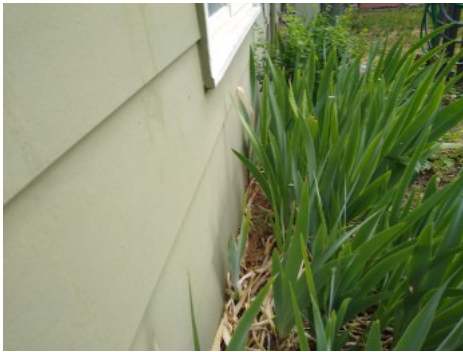
vegetation in contact with siding

- Prune or remove any plants that are in contact or proximity to home to eliminate pathways of wood destroying insects.

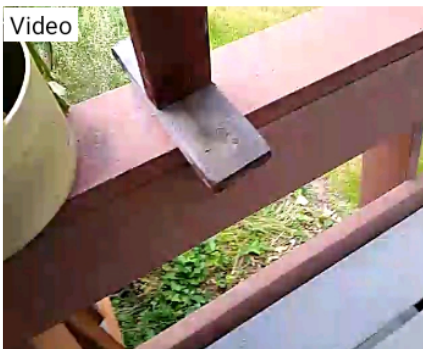
Page 13 Item: 6	Patio and Porch Deck	<ul style="list-style-type: none"> <li>• The porch roof is supported by non conventional and loose framing. Recommend correction and or further evaluation by a licensed contractor.</li> <li>• Upper deck area lacks balusters and posts.</li> </ul>
Interior Areas

- Upper deck area is constructed in a non-conventional manner. It is not framed with a ledger board. Typical deck installations use a ledger board with through-bolts to connect to the house as opposed to using just joist hangers. The deck structure appears to be supported by the stick frame walls of the shed beneath it. Consult with a structural engineer or a qualified, licensed decking contractor to assess the structural validity of the installation.
- The porch roof is supported by non conventional and loose framing. Recommend correction and or further evaluation by a licensed contractor.
- Upper deck area lacks balusters and posts.

loose framing support

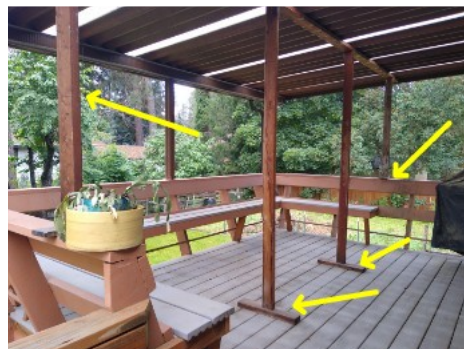
unsecured framing members

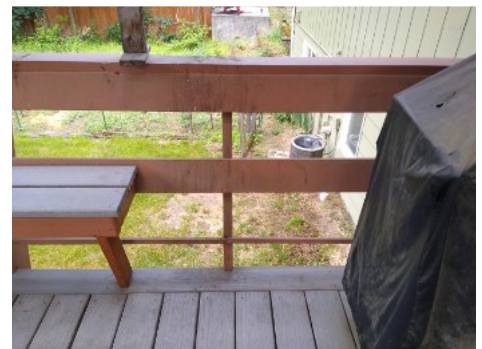
lacks balusters

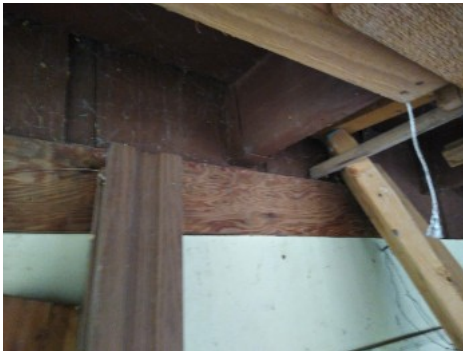
no ledger board

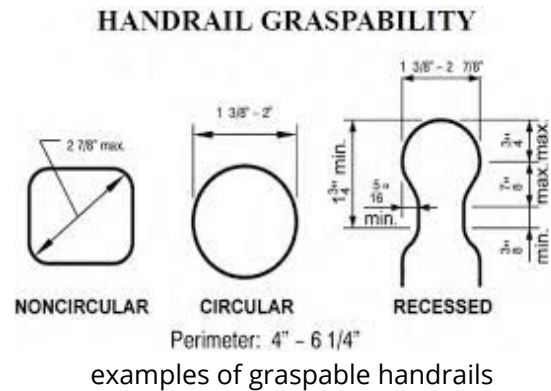
non-graspable rail

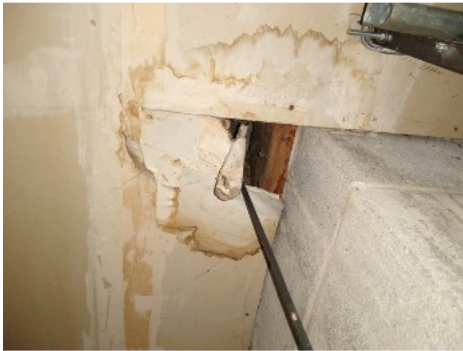
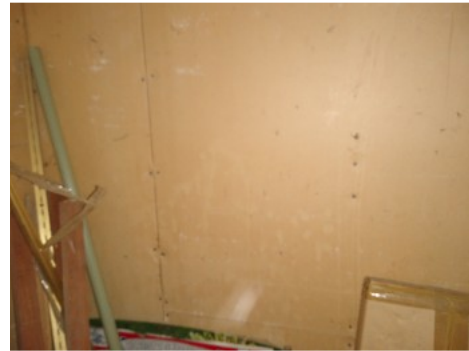
- Firewall into attic space has some holes in it.
- Walls between garages and the living space should be taped to prevent spread in case of fire.

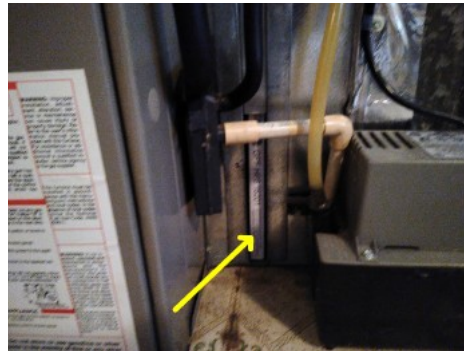
- The furnace filter is blocked by the condensate pump lines and is very difficult to get to. Be sure to change filters on a monthly basis to lengthen the life of the furnace.

filter location

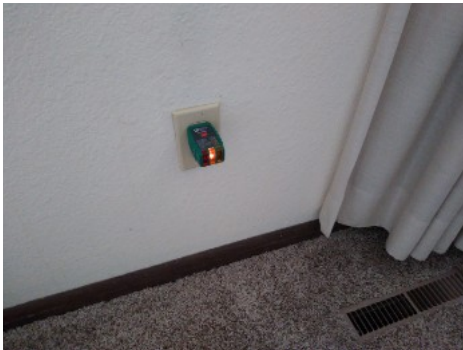
- Loose ground connection in living room area.

open ground condition

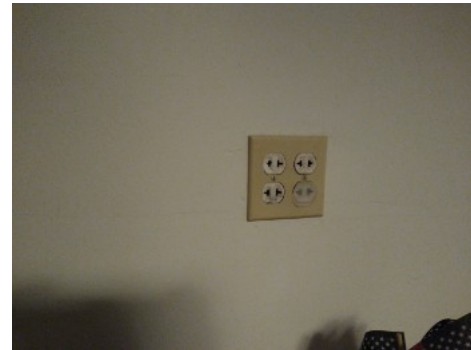
The home contained outdated, ungrounded 2-prong electrical outlets. Although this condition may have been commonly considered safe or acceptable at the time the home was originally constructed, as general knowledge of safe building practices has improved with the passage of time, building standards have changed to reflect current understanding. Consider updating the existing condition to meet generally-accepted current standards.

two prong outlets

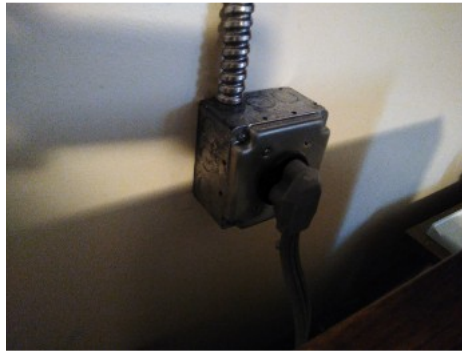
- Older style 3 prong outlet.

3 prong outlet

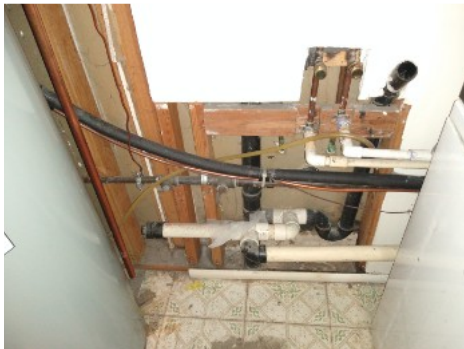
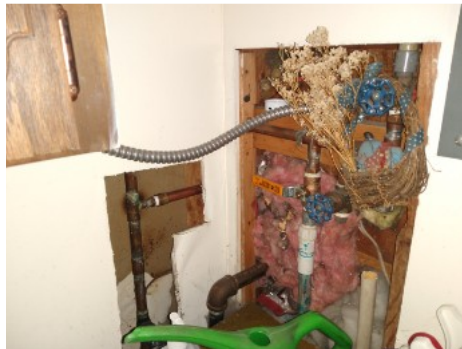
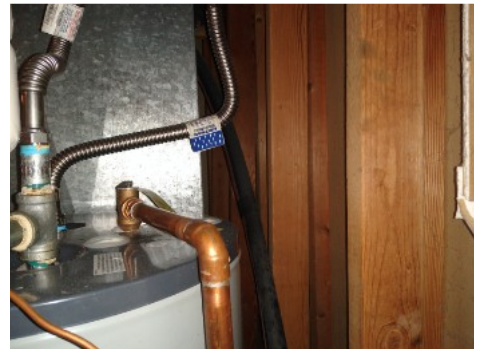
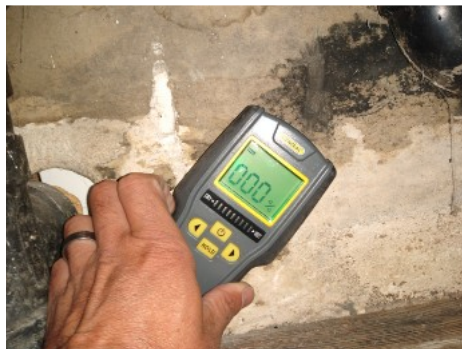
- Several areas of the wall are still open from plumbing remodeling work. Recommend having walls finished with drywall.
- Open wall areas showed 0% moisture reading.
- No active leaks were observed in the open walls at the time of inspection.

0%

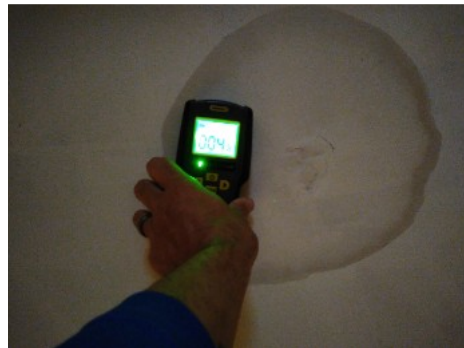
- Drywall ceiling patch by door shows 4% moisture reading.

%4

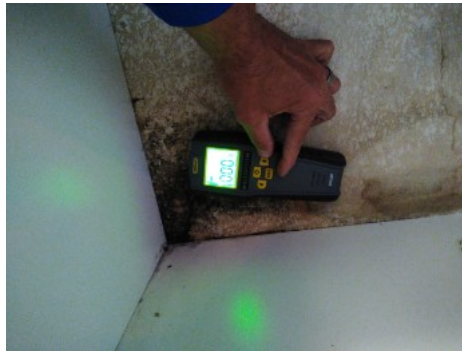
- Few deficiencies in the condition and operation of undersink plumbing. Notable exceptions will be listed in this report.
- Black discoloration under sink shows %0 moisture reading.

0% moisture
