Radon Inspection Report

Measurement of Radon Concentration in Indoor Air

1234 Mullberry Lane
Coeur d'Alene, Idaho 83815
United States

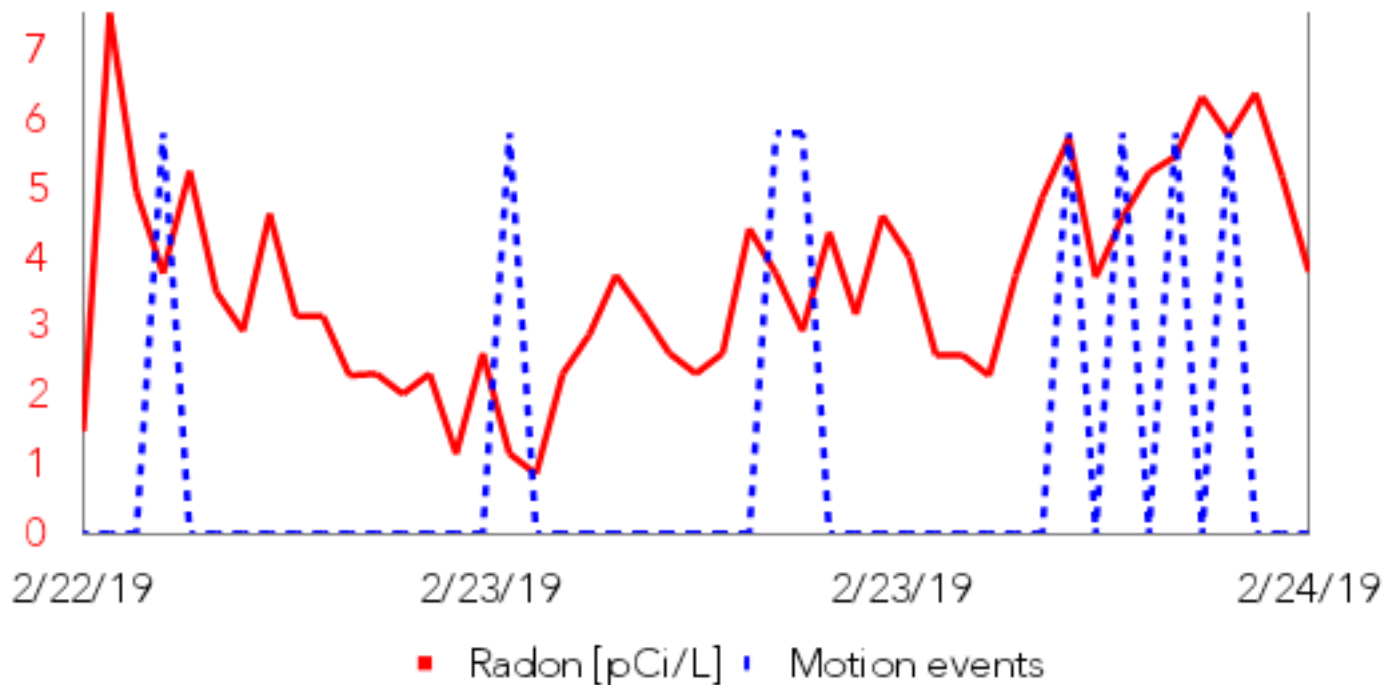
Radon and Motion Chart

Units	Min	Max	Average
Radon [pCi/L]	0.9	7.6	3.6
Temperature [°F]	54.7	63.0	58.0
Humidity [%rH]	38	44	41
Pressure [kPa]	93.54	94.34	94.00

Hour	Radon [pCi/L]	Hour	Radon [pCi/L]	Hour	Radon [pCi/L]
2/22/19 3:54 PM	1.5	2/23/19 7:54 AM	1.2	2/23/19 11:54 PM	2.6
2/22/19 4:54 PM	7.6	2/23/19 8:54 AM	0.9	2/24/19 12:54 AM	2.6
2/22/19 5:54 PM	5.0	2/23/19 9:54 AM	2.3	2/24/19 1:54 AM	2.3
2/22/19 6:54 PM	3.8	2/23/19 10:54 AM	2.9	2/24/19 2:54 AM	3.8
2/22/19 7:54 PM	5.3	2/23/19 11:54 AM	3.8	2/24/19 3:54 AM	4.9
2/22/19 8:54 PM	3.5	2/23/19 12:54 PM	3.2	2/24/19 4:54 AM	5.8
2/22/19 9:54 PM	2.9	2/23/19 1:54 PM	2.6	2/24/19 5:54 AM	3.7
2/22/19 10:54 PM	4.6	2/23/19 2:54 PM	2.3	2/24/19 6:54 AM	4.6
2/22/19 11:54 PM	3.2	2/23/19 3:54 PM	2.6	2/24/19 7:54 AM	5.2
2/23/19 12:54 AM	3.2	2/23/19 4:54 PM	4.4	2/24/19 8:54 AM	5.5
2/23/19 1:54 AM	2.3	2/23/19 5:54 PM	3.8	2/24/19 9:54 AM	6.4
2/23/19 2:54 AM	2.3	2/23/19 6:54 PM	2.9	2/24/19 10:54 AM	5.8
2/23/19 3:54 AM	2.0	2/23/19 7:54 PM	4.4	2/24/19 11:54 AM	6.4
2/23/19 4:54 AM	2.3	2/23/19 8:54 PM	3.2	2/24/19 12:54 PM	5.2
2/23/19 5:54 AM	1.2	2/23/19 9:54 PM	4.6	2/24/19 1:54 PM	3.8
