# PROPERTY INSPECTION REPORT

Apex Home Inspections, LLC

Inspection Prepared For: Random Client

Date of Inspection: 6/20/2019

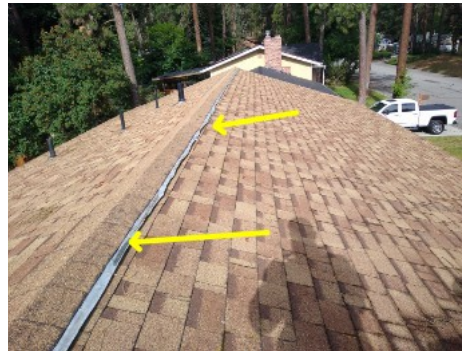
- Light moss on roof. Be sure to check for and treat moss as a part of annual maintenance.
- Some exposed fiberglass and missing granules.

light moss

zinc strip on the ridge will help prevent some moss growth but will not guarantee no moss growth

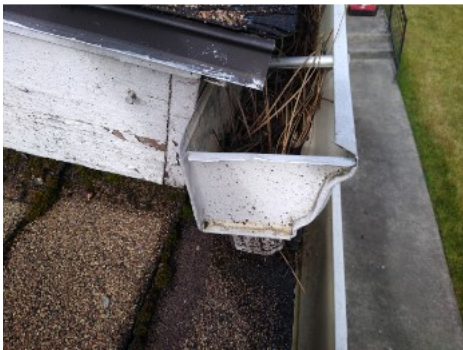
- The roof drainage system consisted of conventional gutters hung from the roof edges feeding downspouts.
- Gutters and downspouts were fabricated from aluminum.
- The gutters had some debris accumulation. Be sure to clean gutters on an annual basis to make sure they function properly.

clean out on a seasonal basis to ensure proper function

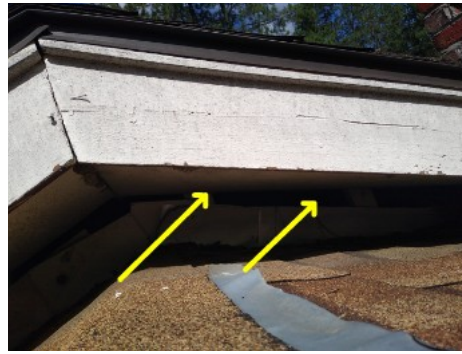
- Sidewall flashing was improperly installed. It is not backed by siding. This area is opened up to the Attic.

opened up to attic

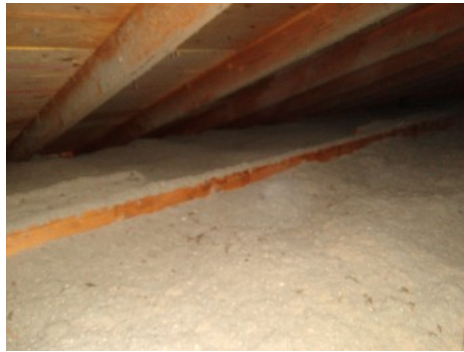
**Depth:** Insulation averages about 4-6 inches in depth; more recommended.

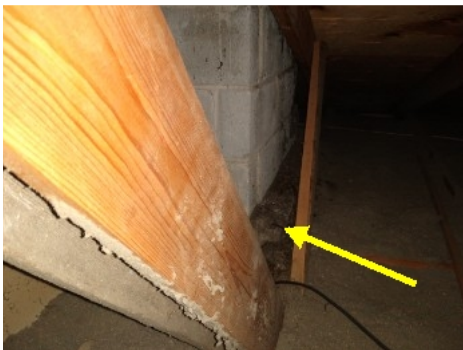
- Debris from roof is visible in the Attic around the chimney area.

pine needles and debris

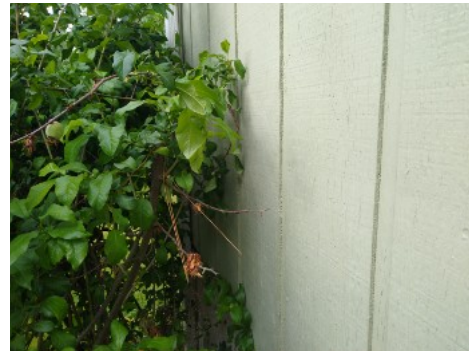
vegetation in contact with siding

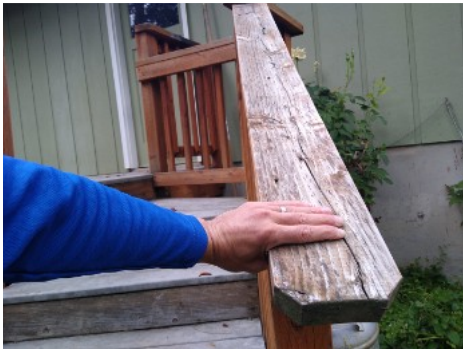
- FYI: The porch stairs had no handrail. Safe building practices dictate that stairs with 4 or more risers should have a graspable handrail.

non-graspable rail

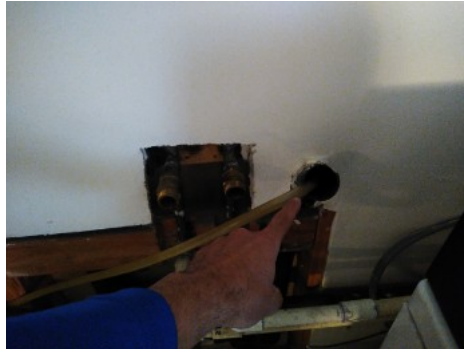
- The high-efficiency furnace exhaust produced condensate fluid that must be discharged to a proper location. Conditions appeared to be acceptable at the time of the inspection.
- The condensate pump drains to the clothes washer discharge line.

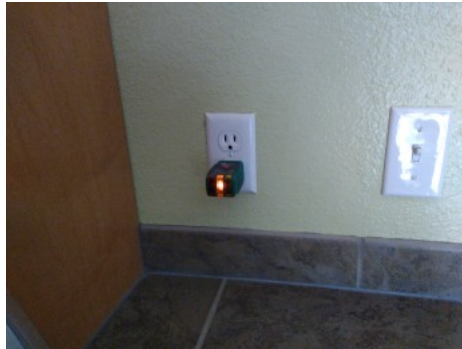
- No GFCI outlets in the kitchen. Although this may have been acceptable at the time of the construction of the house, modern safety standards have GFCI outlets in the kitchen.
- Kitchen outlet shows open ground status.

open ground

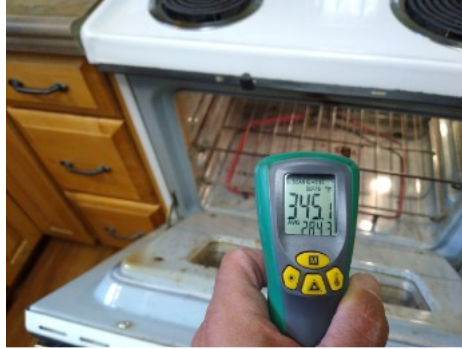
- The Inspector observed no deficiencies during inspection of the oven.

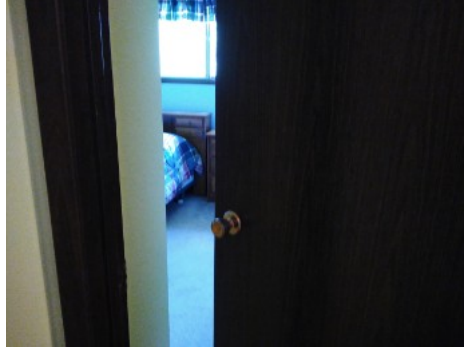
- No deficiencies observed in the condition of interior doors in this room at the time of inspection.

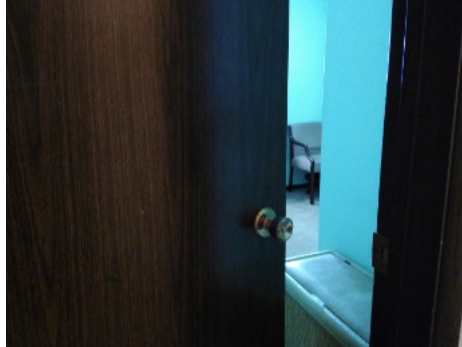
- No deficiencies observed in the condition of interior doors in this room at the time of inspection.

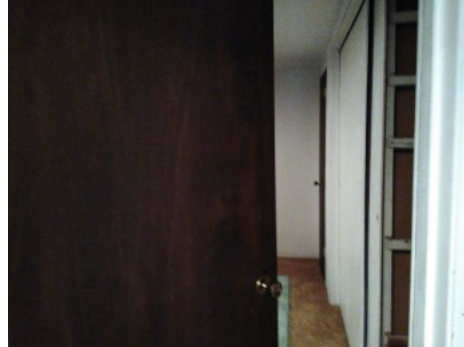
- No deficiencies observed in the condition of interior doors in this room at the time of inspection.

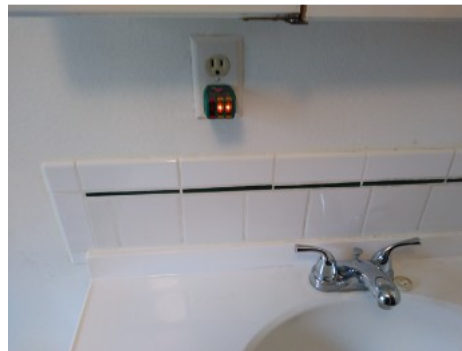
- Not GFCI protected. Although it may not have been a requirement at the time of construction, modern safety standards have GFCI protected receptacles in bathrooms.

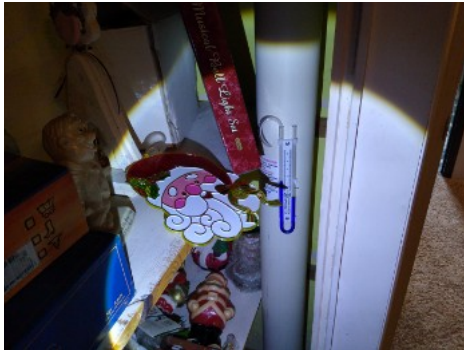
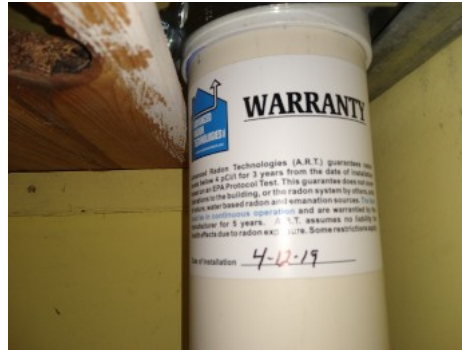
- This house has an active radon mitigation system installed. Active systems use a continually running low voltage fan to create negative pressure below the house's lowest level to trap the radon then the gas is evacuated to the exterior of the house. Observation of a radon system is not a guarantee of its performance. The only way to know if the system is effective is to test for radon.
